Tyre Related Accidents and Incidents - A Study with Recommendations to improve Tyre & Rim Maintenance and Operational Safety of Rubber Tyred Earthmover Equipment

**C15046
May 2007**

Project Number C15046

Tilman Rasche
Tom Klinge
Klinge & Co
Tyre Management Consultants, Brisbane

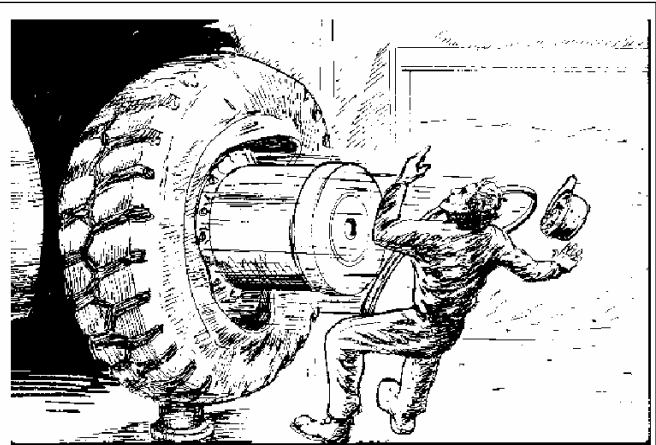
Failure of rim/locking mechanisms during wheel maintenance is one of the highest cause of all tyre maintenance fatalities (sketch from [2])

- Mandatory deflation/pressure reduction of tyre assemblies prior

to removal off any vehicle, as required by AS4457:1997 must be in place, particularly when considering the high frequency of incidents involving LTA integrity of rims, and rim componentry. Both factors combined have caused several fatalities in the last few years in Australia.

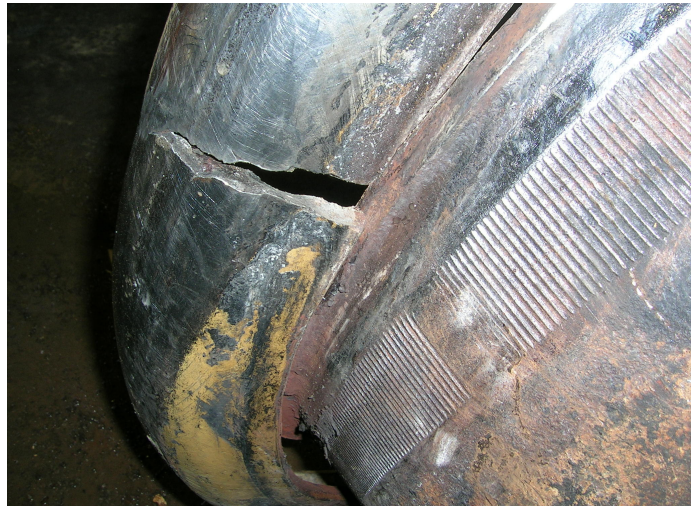
Photograph 1: Fatigue damage of rim and rim components, if not detected, such as this flange ring can have catastrophic consequences.

- Rim integrity generally must be assured throughout the lifecycle of the rim assembly. A strategy to achieve this must incorporate, as a minimum, reliable non destructive testing (NDT) regimes in accordance with Australian Standards, OEM and industry guidelines and a higher level of understanding of the issue and underlying hazards. The strategy must also include accurate recording, tracking and reporting of the NDT and fatigue status/history so rims/wheels can be withdrawn before their permissible fatigue limit is reached.

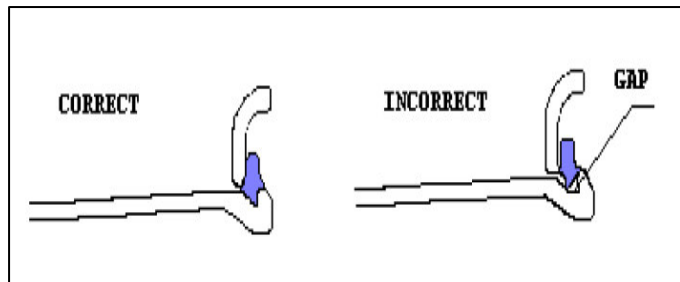
Incorrect matching and assembly of tyres, rim and rim components, as shown, must be eliminated to ensure the safety and integrity of the assembly. (sketch from [1])

- Matching of tyres, rims and rim components must be ensured to achieve full operational safety and performance after assembly.
- Safe load shifting practises including safe position of the operator of the crane manipulator/crane must be achieved,

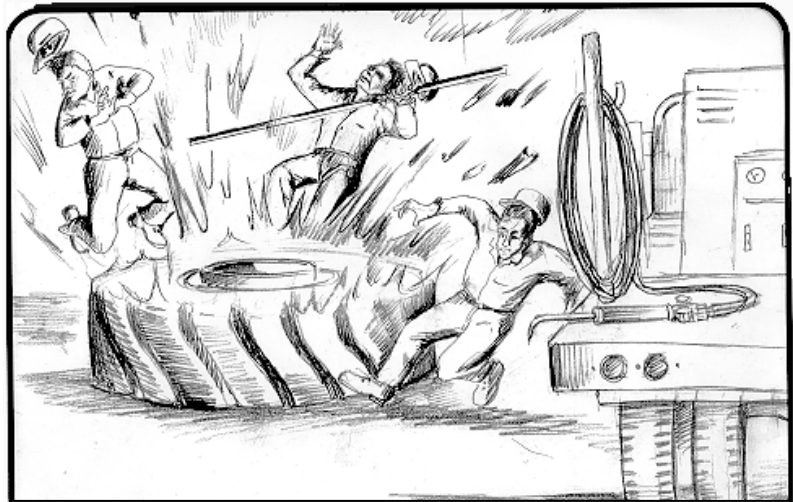
Heating of wheel fastening systems is a key root cause to many tyre and rim related fatalities. This work practise must be eliminated. Sketch from [4].

- Heating of wheel assembly fastening components appears to be widespread practise within the industry, common knowledge and understanding must be imparted on all personnel that this practise is extremely dangerous and cannot be tolerated.

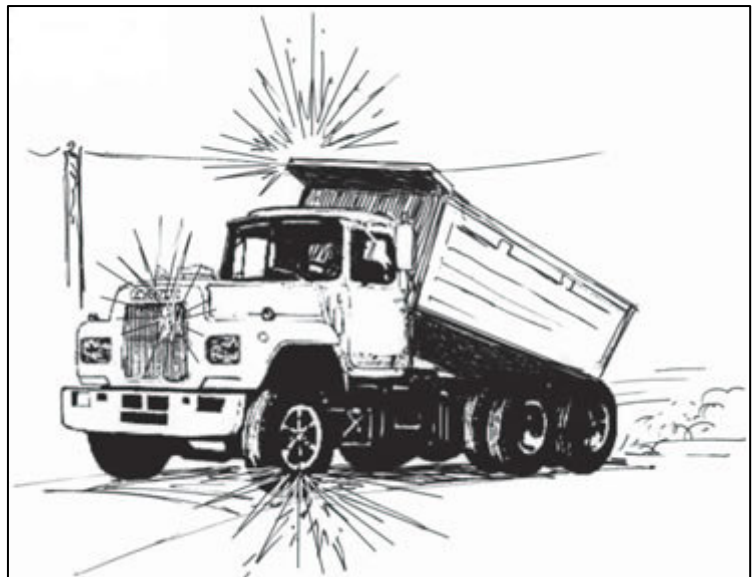
Accidental contact with overhead powerlines, or electrification by lightning strike is known to cause pyrolysis and subsequent violent explosion of in some or all vehicle tyres. This hazard can be best eliminated by designing roads away from powerlines. (sketch from [31])

- One key operational issue directly related to LTA design of mine layout is the positioning and routing of powerlines. Accidental contact by mining

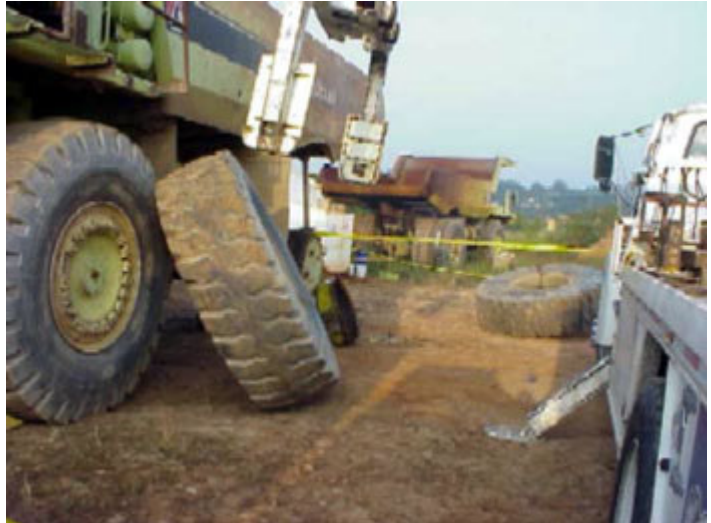
Photograph 2: Congestion in the workplace, combined with handling of tyres using crange equipment is a prime cause for a number of fatalities. (image from [5])

- A restricted or confined working environment may also give rise to personnel deciding to or 'being forced' to work in situations where they may expose themselves to suspended loads. Where such situations apply, separate risk assessments ought to be conducted and followed through. Unstable crange equipment and uncertified lifting equipment must not be used at any time.

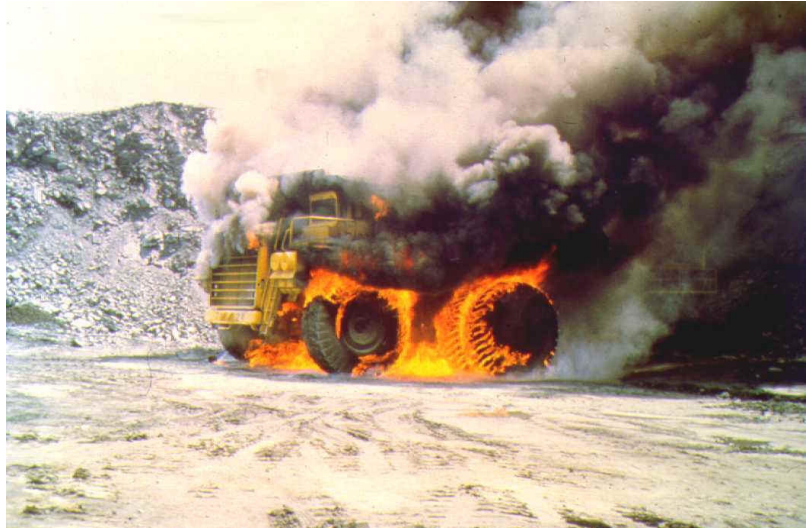
Photograph 3, while prevention is the best approach to reduce risks, emergency response to situations like this must be adequate and well rehearsed.

assembly cavity must be provided to all personnel that may be required to deal with such emergency situations, this should include equipment operators including water cart operators, supervisors, emergency response crews and management.

- Fire fighting and emergency rescue capability as related to tyre and rim incidents, both in terms of HR as well as equipment must be examined in view of potential scenarios on mining sites.
